ReBuild

Vol. 3 No. 4 (Oct-Dec 2009)

**PRESEREVATION, REHABILITATION
AND
RESTORATION OF HISTORIC STRUCTURES**

Preservation, Rehabilitation and Restoration of Historic Structures

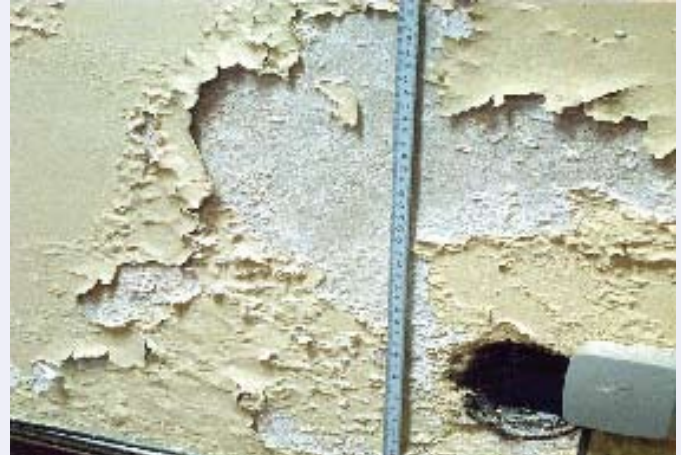
Fig: 2 Salt damage of weak pointing material

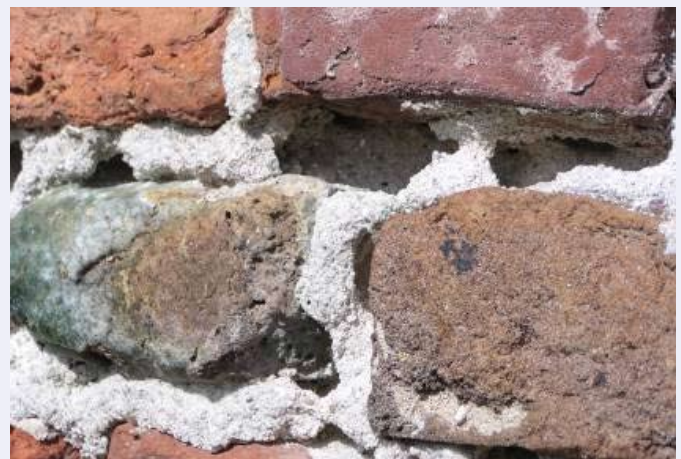
Fig: 3 Damage through salt Crystallization

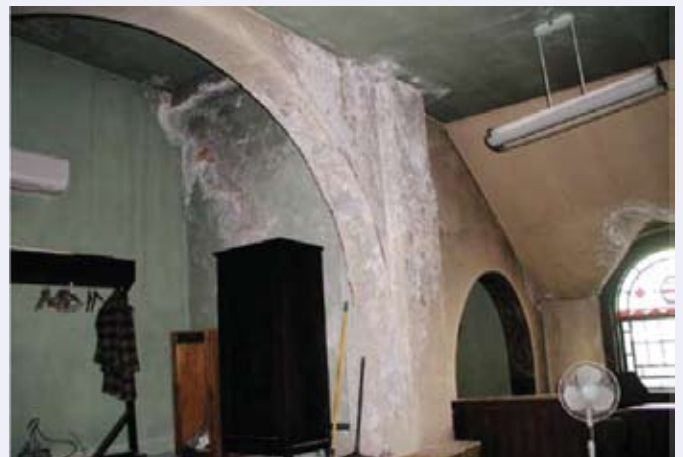
Water that made its way into the bell tower would pool on the third level's concrete floor and then seep through to the second level and into the choir area of the church below. The plaster on the ceilings and walls of the church was being destroyed (Figures 2 & 3) by the water damage. But most distressing was the fact that the many historic religious paintings were being damaged and destroyed (Figure 4).

Fig 3: Distress in internal walls

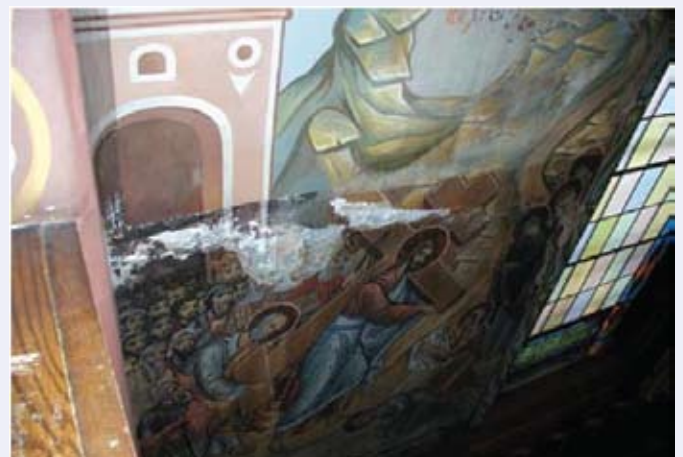
Fig 4: Damages in wall paintings
