ReBuild

Vol. 3 No. 4 (Oct-Dec 2009)

**PRESEREVATION, REHABILITATION
AND
RESTORATION OF HISTORIC STRUCTURES**

Preservation, Rehabilitation and Restoration of Historic Structures

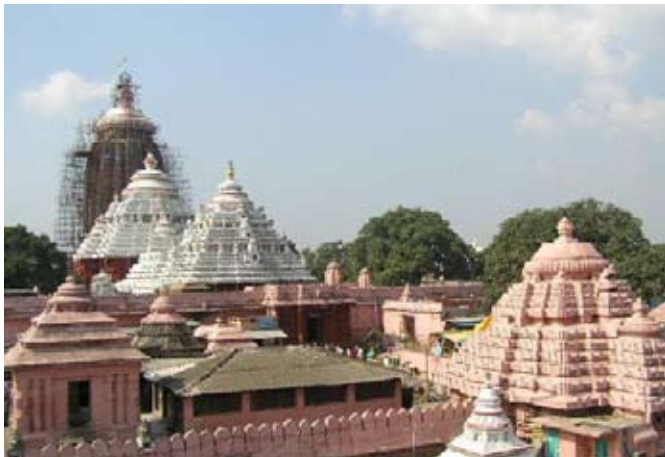
Fig: 1 View of temple complex

The maximum damage to the temple was caused by the rusting of these clamps. Apart from this the stone expanded due to seepage, generating pressure and causing chunks to fall.

The outer faces which was covered with lime plaster (about 45cm) had failed to control saline induced deterioration and leakage besides putting extra pressure on the fabric of the temple and hiding the beautiful carvings.

It was found that the condition of the inner walls and corbels required attention. Similarly, on the southern side of the temple major structural weakness were detected in the form of multiple cracks, missing architectural pieces, etc.

- I. Replacement of missing corbels as per the original.
- II. Replacement of rusted wrought iron cramps by stainless steel cramps.
- III. Sealing of the stone joints by a joint sealant comprising stone dust, cement, polymer (acrylic type) and non-shrink additives.

- IV. Grouting the inner core with polymer modified, flexible, non-shrink, cement grouts.
- V. Anchoring the loose cantilevers and corbel stones with help of 1.5m to 2.5m long, threaded stainless steel anchors, grouted with low viscous epoxy resins.

- VI. Providing a stainless steel anchors, grouted with low viscous epoxy resins.
- VII. Providing a stainless steel space frame, as a secondary defence to support the ground floor corbelled roof.

- VIII. Lateral confinement of the entrance corner walls of each floor by stainless steel flats.
- IX. Improvement to the existing ventilation system by drilling appropriate diameter holes through the ceiling of the first and second floor and provision of suitable ventilation duct in the top floor.
